Collector Repair if Leaking at the Header

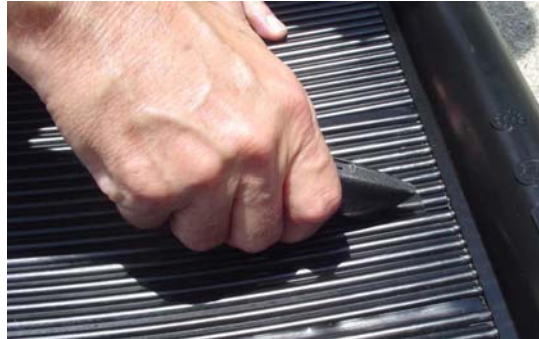
STEP 1

Collector Repair
Tools for header
repair screw
#2RSM

Once the leaking tube has been located, separate the webbing from the tube by cutting the center of the web parallel with the tube on each side, downward a few inches away from the header. This process is much easier and safer with a sharp razor knife.

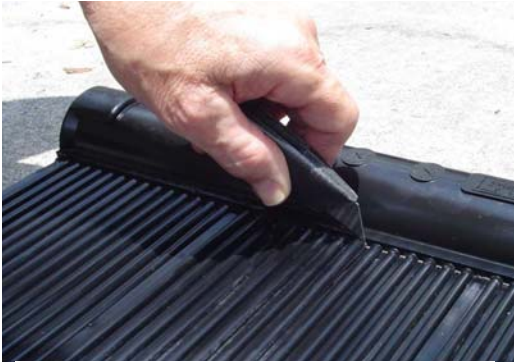
STEP 2

Carefully cut the damaged tube where it connects to the header. Do not cut adjacent tubes.

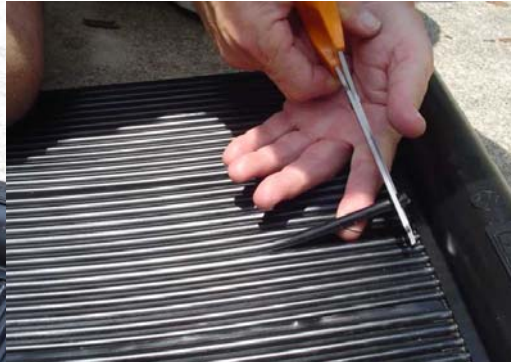
STEP 3

Separate the header from the tube. With a pair of sharp scissors cut off approximately 1/8" of the tube.

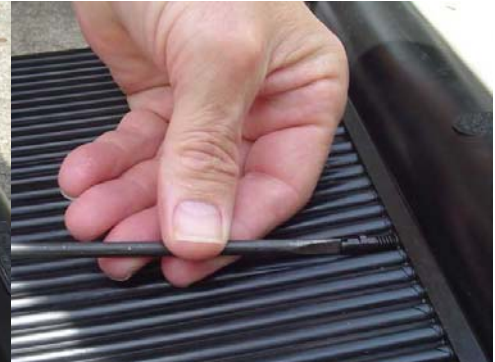
STEP 4

Insert repair screw #2RSM into the molded hole in the header. Note: The application of poly roof sealant to the screw before inserting is recommended.

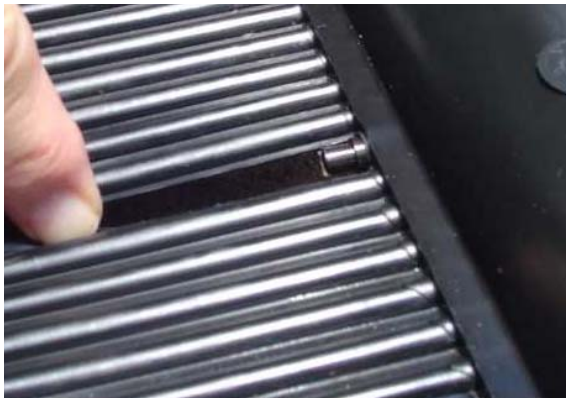
STEP 5

Screw in snugly until it finishes flush with header.

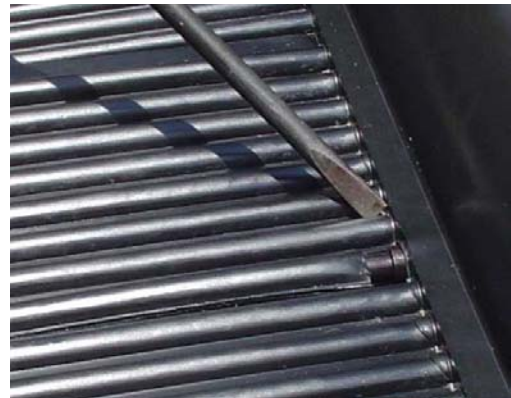
STEP 6

Slip the cut end of the tube over the protruding end of the screw (for aesthetics).

Repeat the process on the other end of the same tube at the opposite end of the collector.
This prevents water from entering the damaged tube from either end of the panel!
